# **CHARACTERIZATION OF SANDWICH PANELS SUBJECT TO LOW-VELOCITY IMPACT**

Non-Destructive and Destructive Inspection of  
Non-standard Sandwich Composite Panels

A Thesis Submitted to the Division of Graduate Studies  
of the Royal Military College of Canada  
by

In Partial Fulfillment of the Requirements for the Degree of  
Master of Applied Science in Aeronautical Engineering

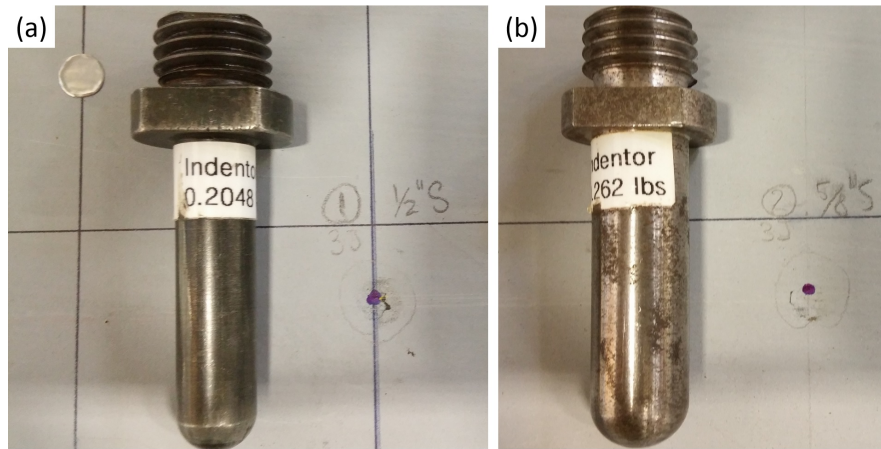
Figure 4.6: B11 (a) 12.7 and (b) 15.9 mm impact, showing paint chipping; impact locations pre-marked with a blue pen and circled lightly with pencil for aligning impactor during test.

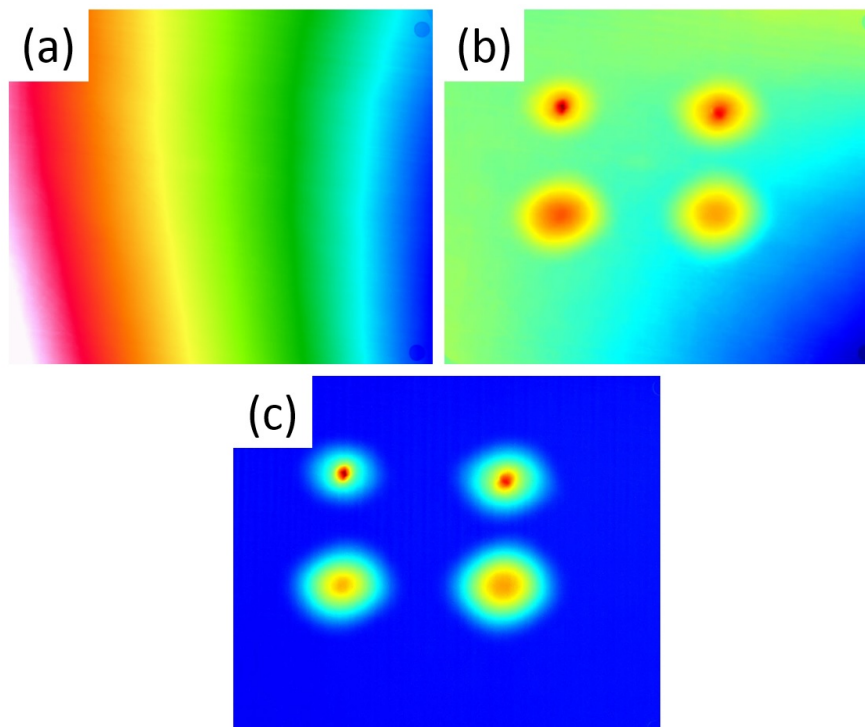
Figure 4.12: B11 (a) before impact showing panel curvature, (b) after impact showing dents and panel curvature, and (c) deviation map showing only dents and no panel curvature. Colours qualitatively show panel curvature and dent profile.

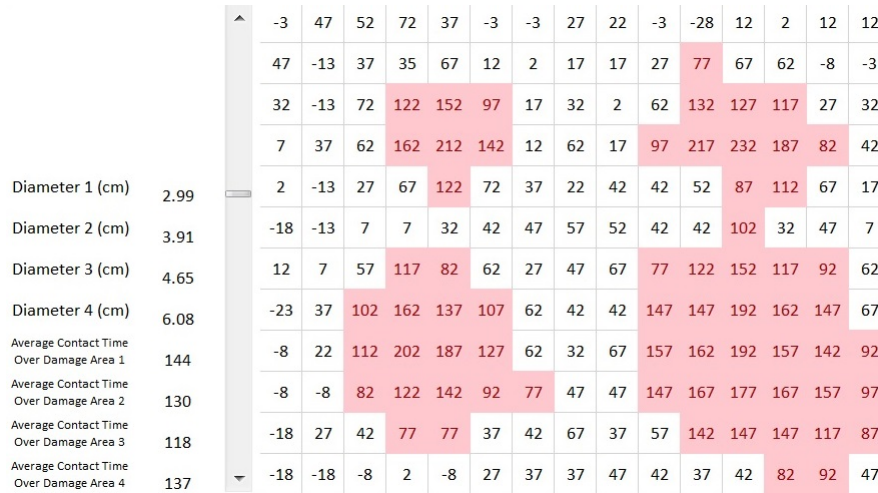
Figure 4.19: Damage map for B11 ( $\mu s$ )

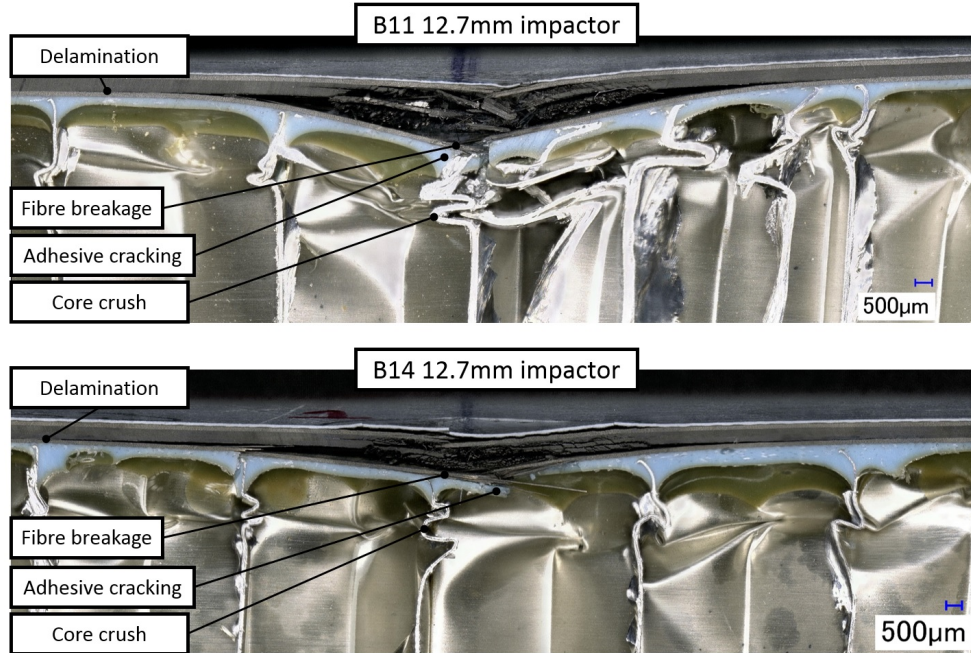
Figure 4.22: B11 and B14 12.7 mm impact cross section with laminate damage, adhesive cracking and core crush.

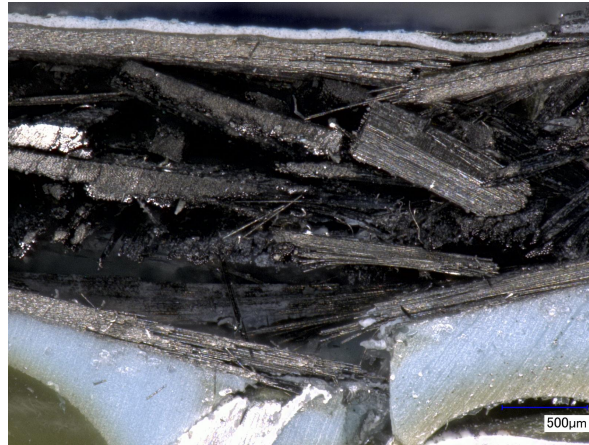
Figure 4.23: B11 12.7 mm local impact zone.

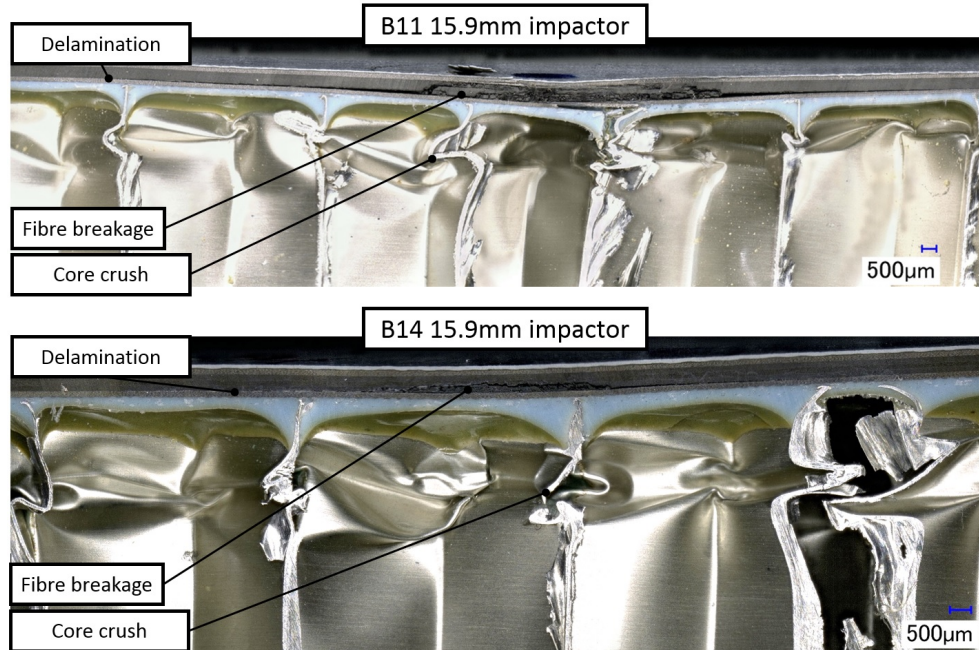
Figure 4.25: B11 and B14 15.9 mm impact cross section with laminate damage and core crush.

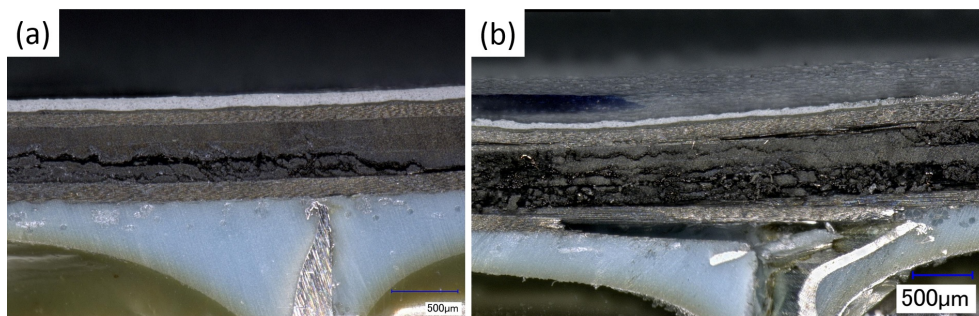
Figure 4.26: 15.9 mm impact of B14 (a) 2.84 J and B11 (b) 3.06 J showing greater laminate damage for higher energy impact.

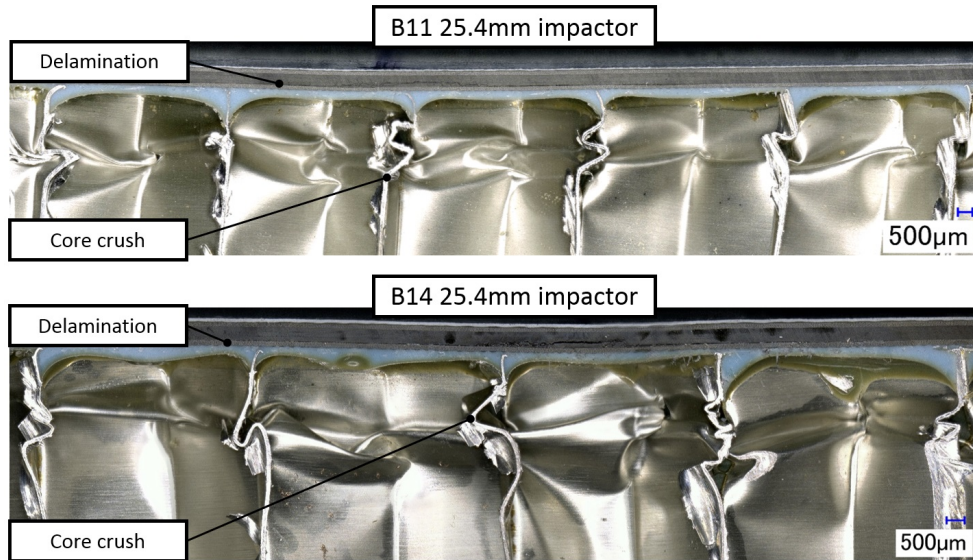
Figure 4.27: B11 and B14 25.4 mm impact cross section with delamination and core crush. Discolouration of B14 laminate due to diamond blade cutting through tape that was affixed to the top of the panel.

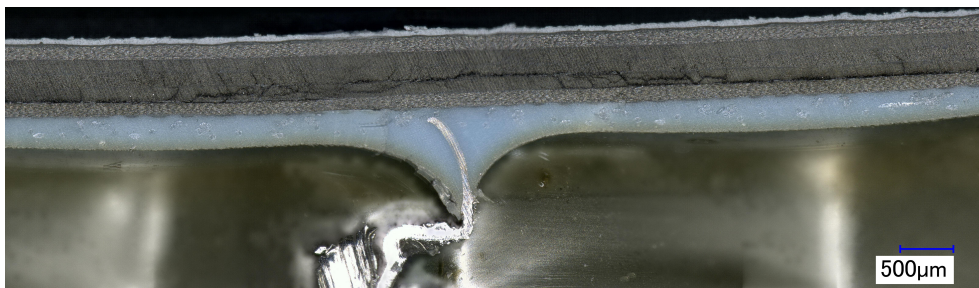
Figure 4.28: B11 25.4 mm impact delamination.

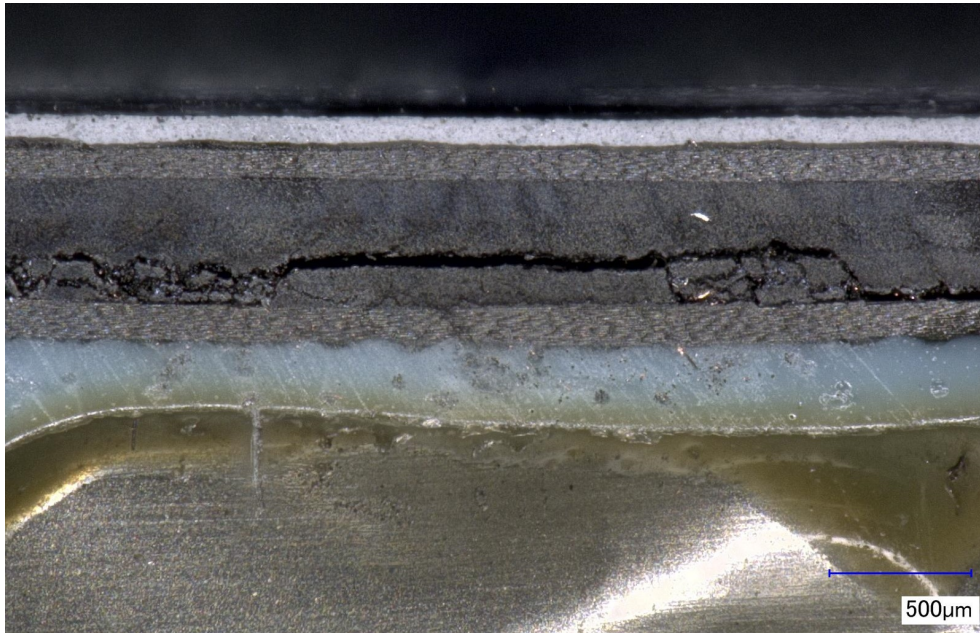
Figure 4.29: Delamination for B14 25.4 mm impact.

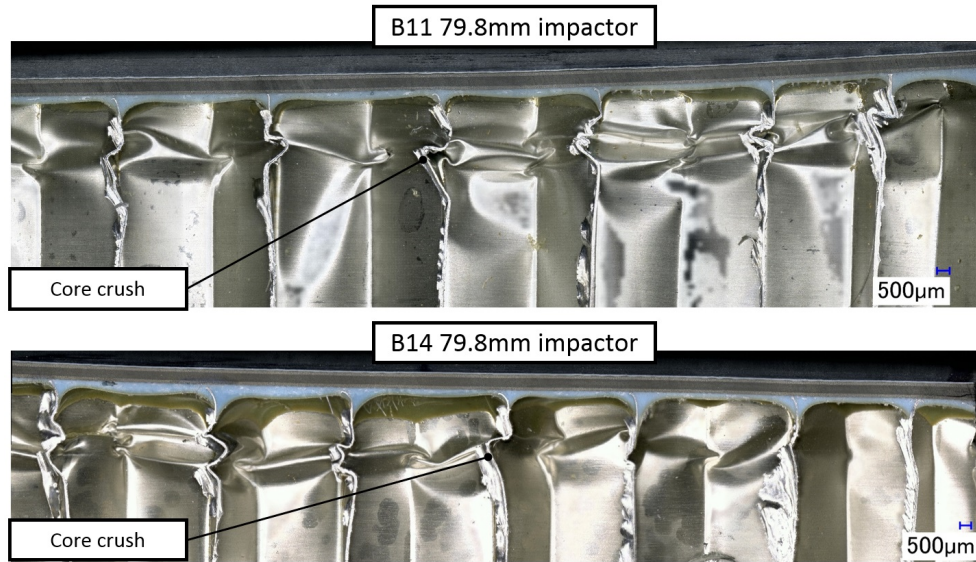
Figure 4.30: B11 and B14 79.8 mm impact cross section with core crush.

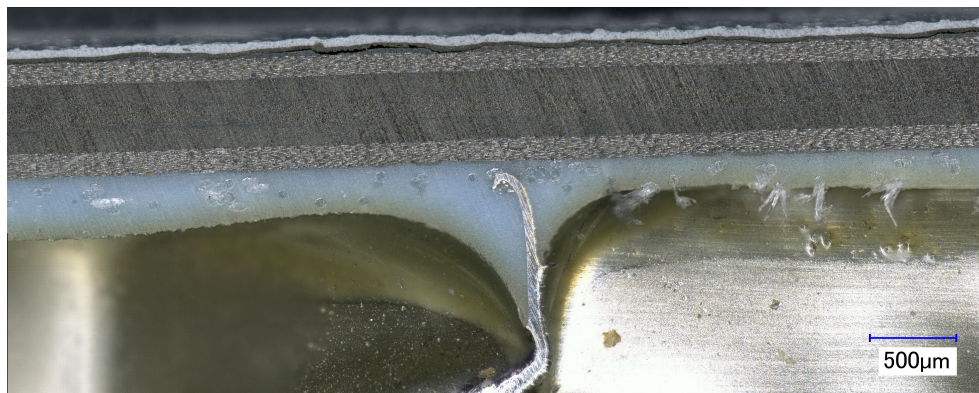
Figure 4.31: B11 79.8 mm impact with no laminate damage.

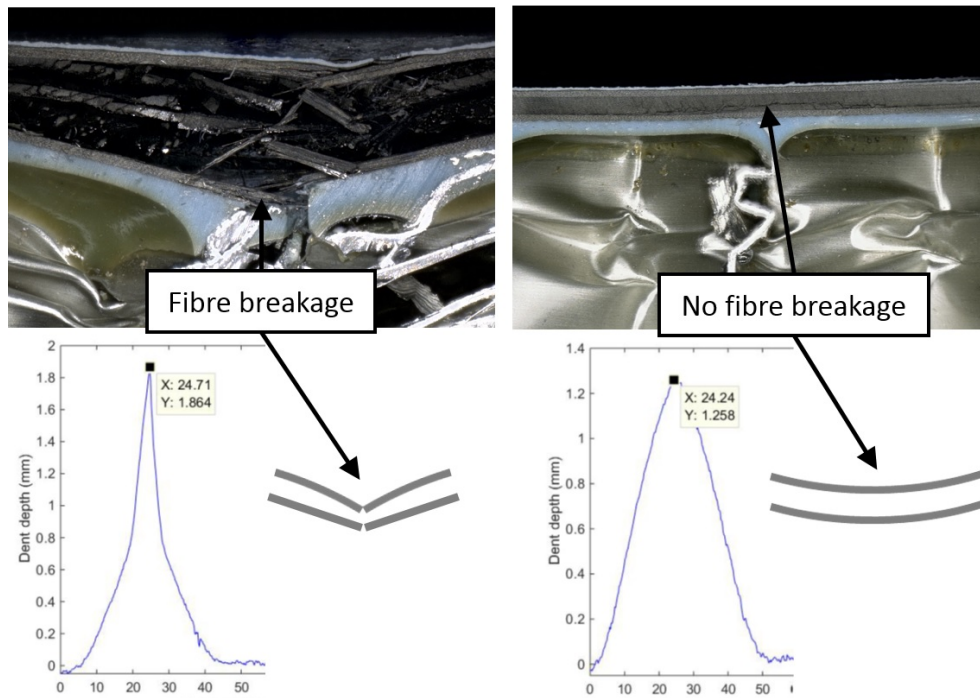
Figure 4.33: Impact failure mode and laser topography curvature for B11 12.7 mm (left) and 25.4 mm impactors (right). The sharper profile on the left may be indicative of significant laminate damage, and may be useful for characterization of impact damage.

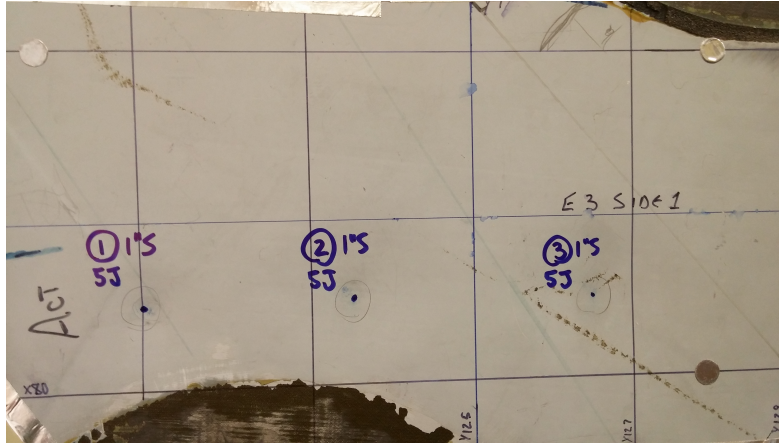
Figure 4.39: E3 post-impact with all dents visible.

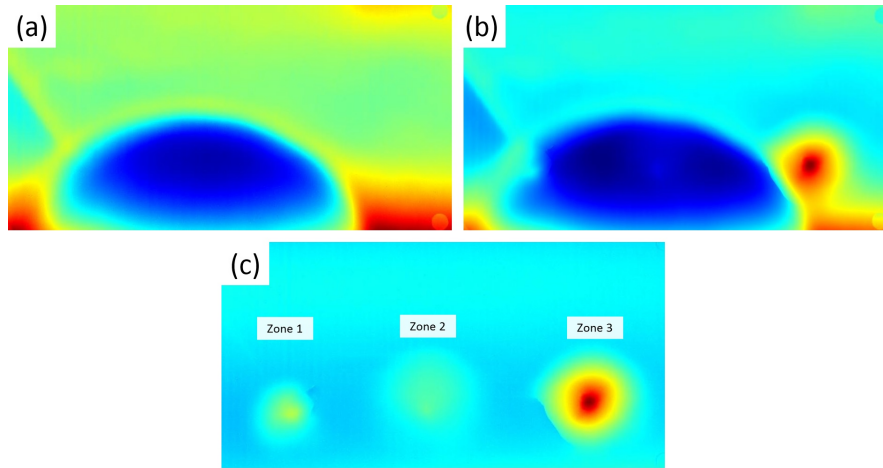
Figure 4.43: E3R (a) before impact, (b) after impact, and (c) deviation map showing faint depth profile for zone 1 and a barely noticeable depth profile for zone 2 when compared panel E3 topography.

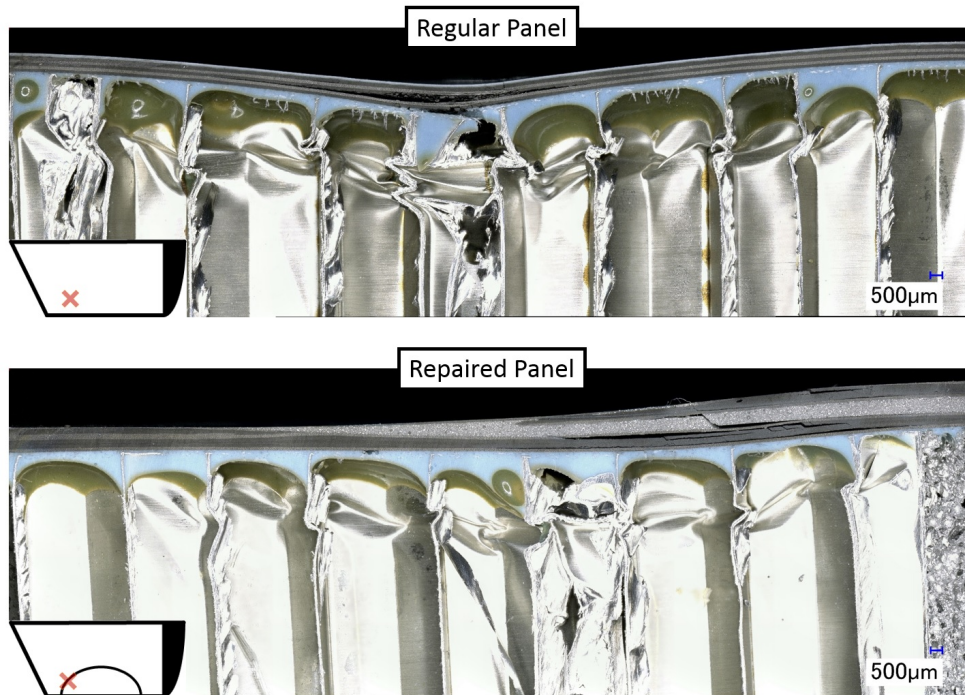
Figure 4.44: Regular (E3) and repair (E3R) panel zone 1 cross-sections. E3 has incurred significant laminate damage, delamination, adhesive cracking and core crushing. The E3R impact occurred at the edge of the repair patch, and caused delamination and shear cracking in the laminate, cracked potting compound and core crushing. Location on panel noted at bottom-left corner of cross-sections.

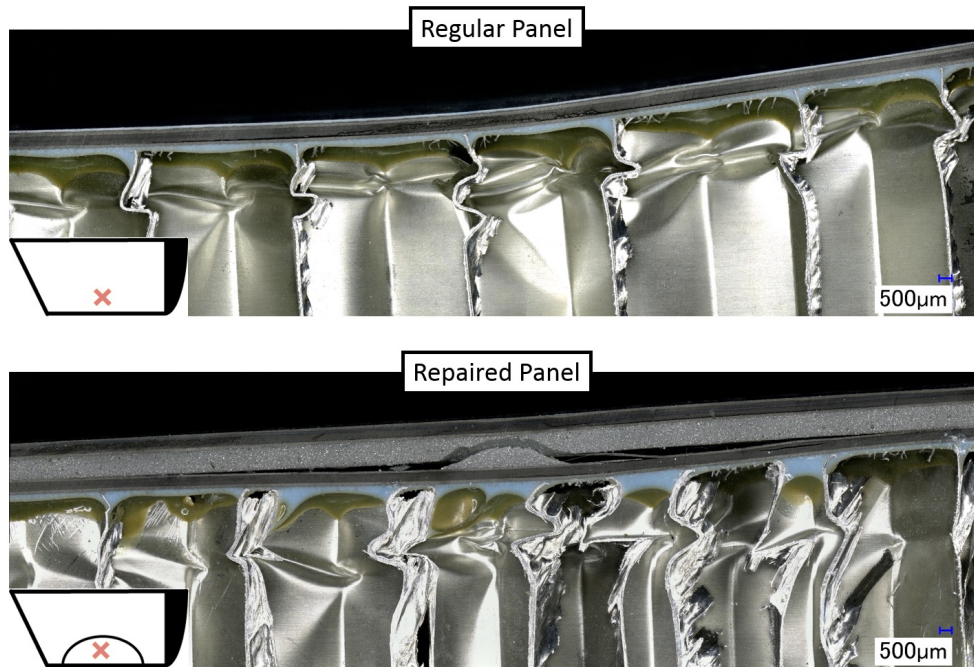
Figure 4.45: Regular (E3) and repair (E3R) panel zone 2 cross-sections. E3 has some laminate damage and a delamination extending between the fourth and fifth ply, as well as some core crushing. E3R shows core crushing along with some delamination at both the upper and lower ply, as well as a significant crack in the potting compound between the patch laminate and the underlying panel laminate. Location on panel noted at bottom-left corner of cross-sections.

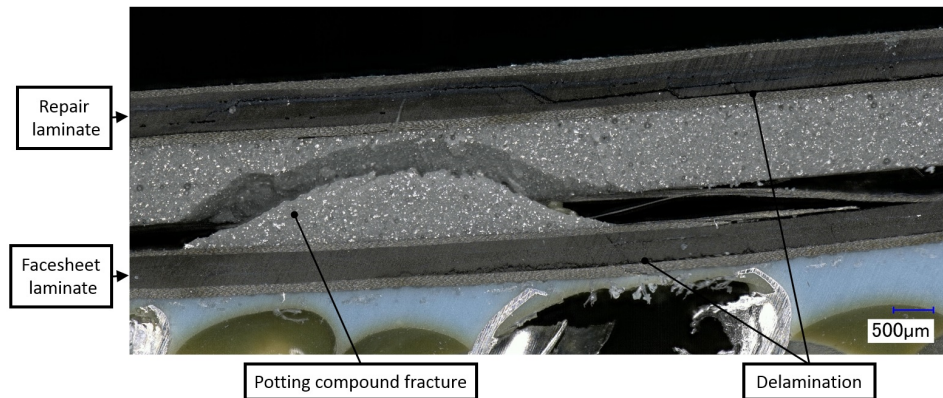
Figure 4.46: E3R zone 2 delamination and damaged potting compound.

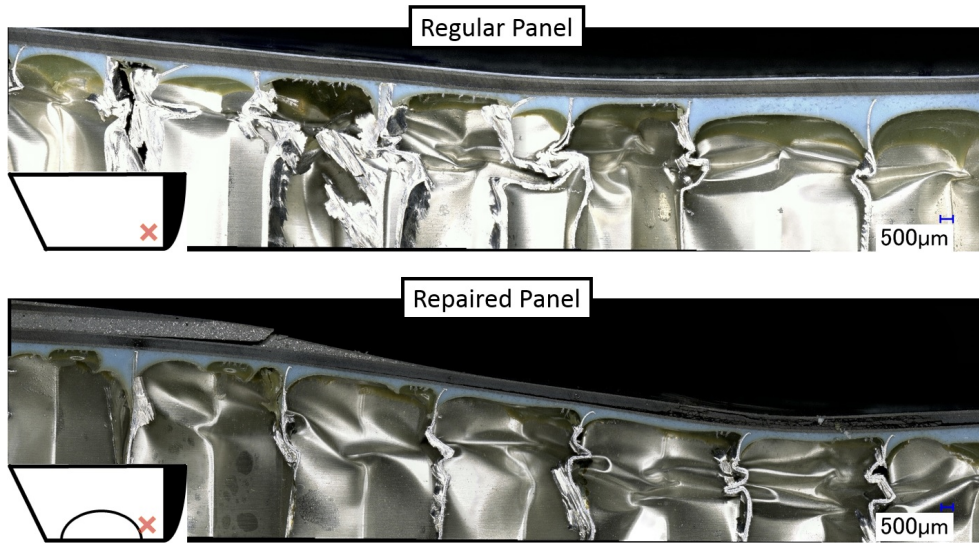
Figure 4.47: Regular (E3) and repair (E3R) panel zone 3 cross-sections. E3 has delamination between the fourth and fifth ply, as well as core crushing. E3R has more significant laminate damage as well as delamination, with a crack in the potting compound at the left side of the cross-section where the repair ends. E3R also has more core crush than E3. Location on panel noted at bottom-left corner of cross-sections.

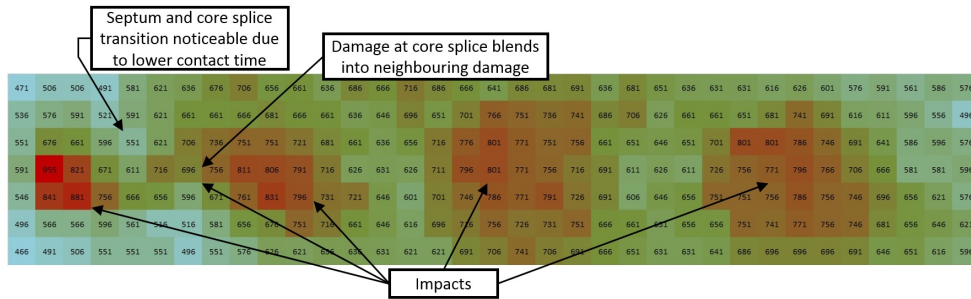
Figure 4.53: D21 after impact C-scan tap test. Four damages clearly identifiable with core splice impact blended into adjacent damage. Septum is the area of lower contact time.

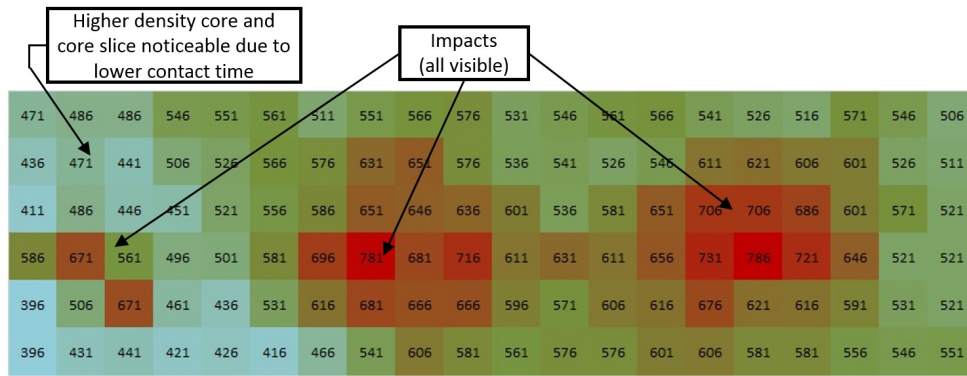
Figure 4.56: E3 after impact C-scan tap test. Higher core density, splice and impacts identified.

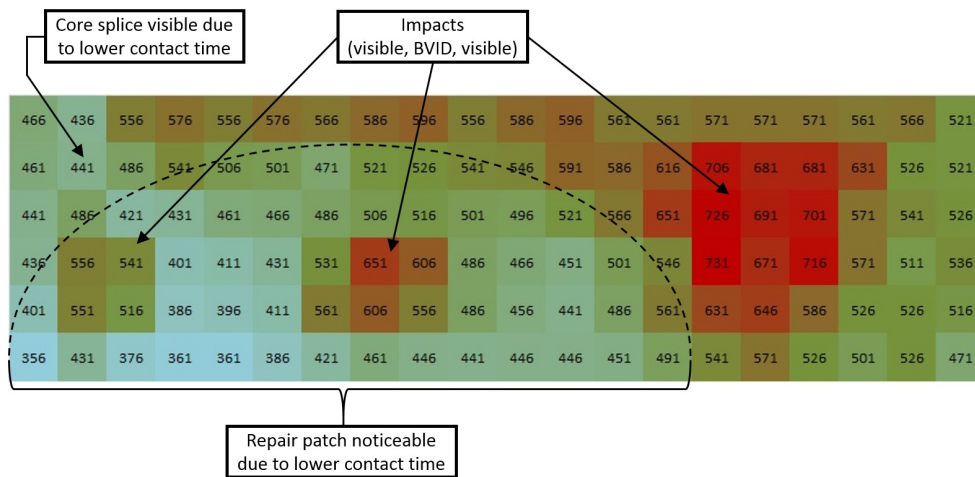
Figure 4.59: E3R after impact C-scan tap test. Core splice, repair patch and impact locations noted.

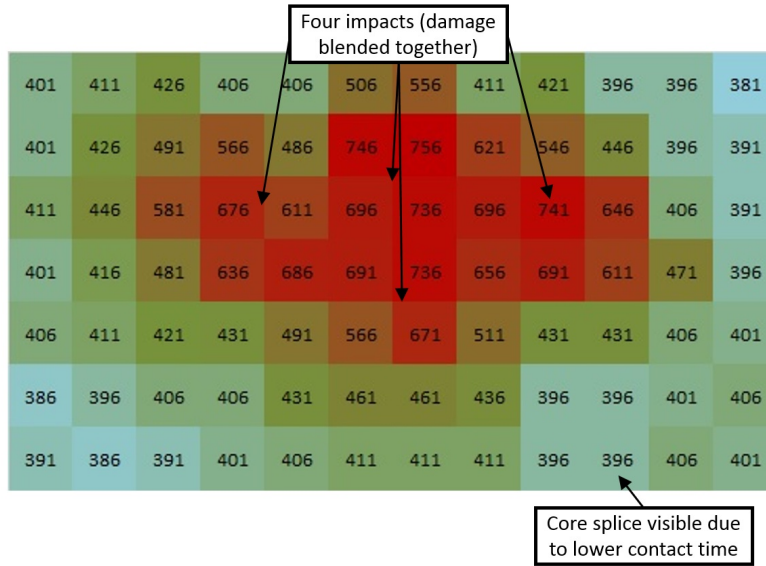
Figure 4.62: F3 after impact C-scan tap test. Four BVID impacts and core splice noted.
