DETECTION OF LOW-VELOCITY IMPACT  
DAMAGE IN CARBON FIBER SANDWICH  
PANELS USING INFRARED THERMOGRAPHY

A Thesis Submitted to the Division of Graduate Studies  
of the Royal Military College of Canada

In Partial Fulfillment of the Requirements for the Degree of  
Master of Applied Science in Aeronautical Engineering.

January 2019

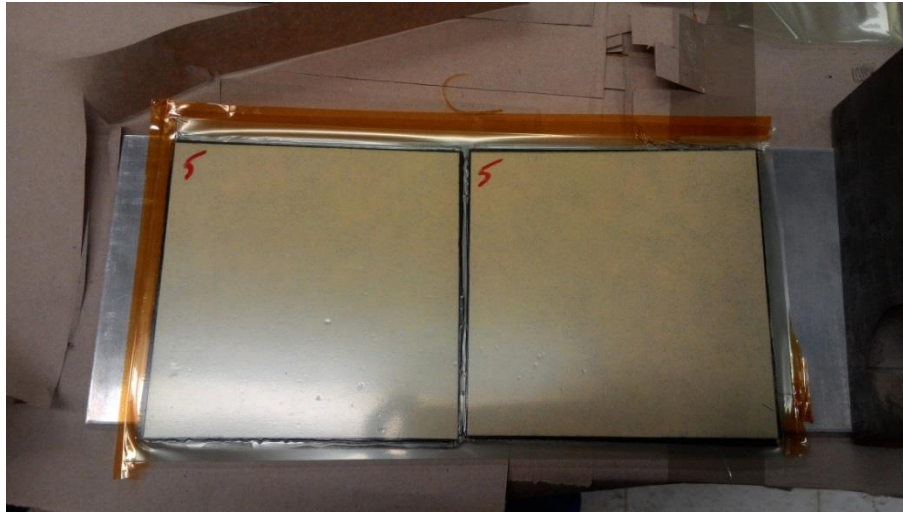
Figure 22: Two face sheets (5 ply, [0/90/0/90/0]) vacuum pressed together and ready for curing.

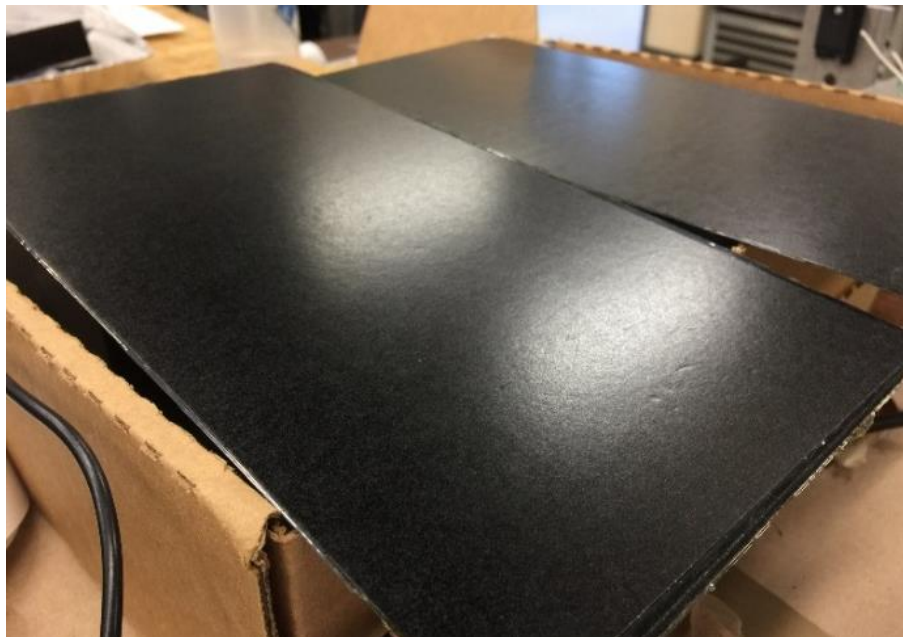
Figure 24: Two 152 mm x 305 mm (6.0 inch x 12 inch) (5 ply, [0/90/0/90/0]) post-cured face sheets.

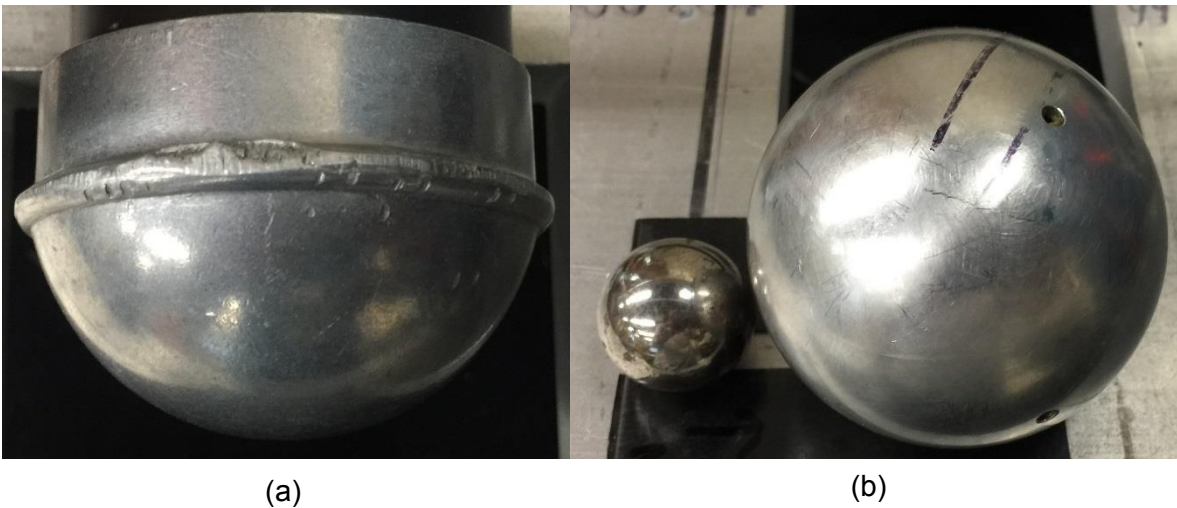
Figure 28: (a) Impactor 1 with a mass of 0.150 kg, and a diameter of 52.6 mm. (b) Impactor 2 with a mass of 0.067 kg and a diameter of 25.4 mm and impactor 3 with a mass of 1.030 kg and a diameter of 63.1 mm.

To recreate impact damage that may occur during a honeycomb panel's service life provided by the first six bullet points above, an impact tower was designed and built. Building the impact tower allowed different parameters to be altered such as the mass of the impactor (0.067, 0.150 and 1.010 kg), the diameter of the impactors (25.4, 52.6 and 63.1 mm), and the drop height (0.2-2.14 m). The specifications for each are given in Table 5 and examples are shown in Figure 28.

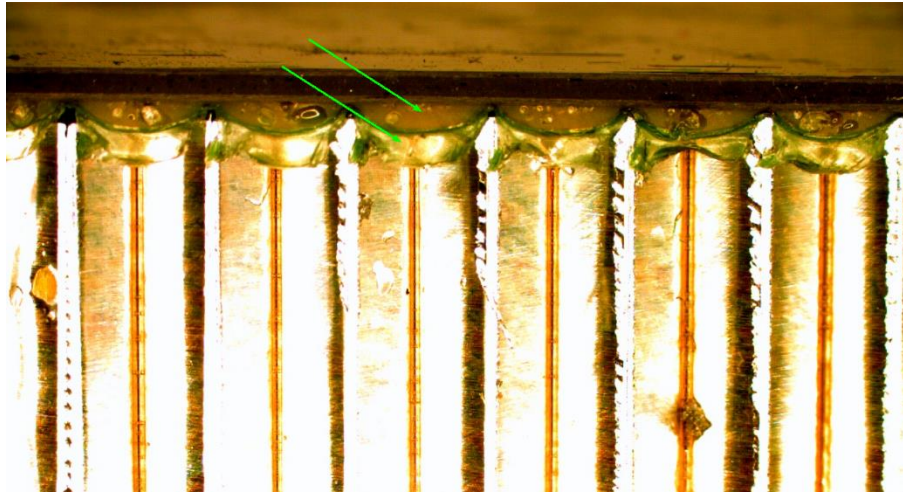
Figure 34: Excess adhesive created by adding an extra layer (Green) of film adhesive before the curing process.

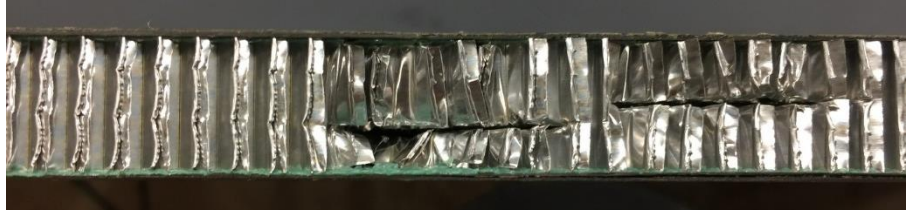
Figure 37: Horizontally sliced honeycomb core. This was created by pushing an X-Acto knife blade into the side walls of the cells.

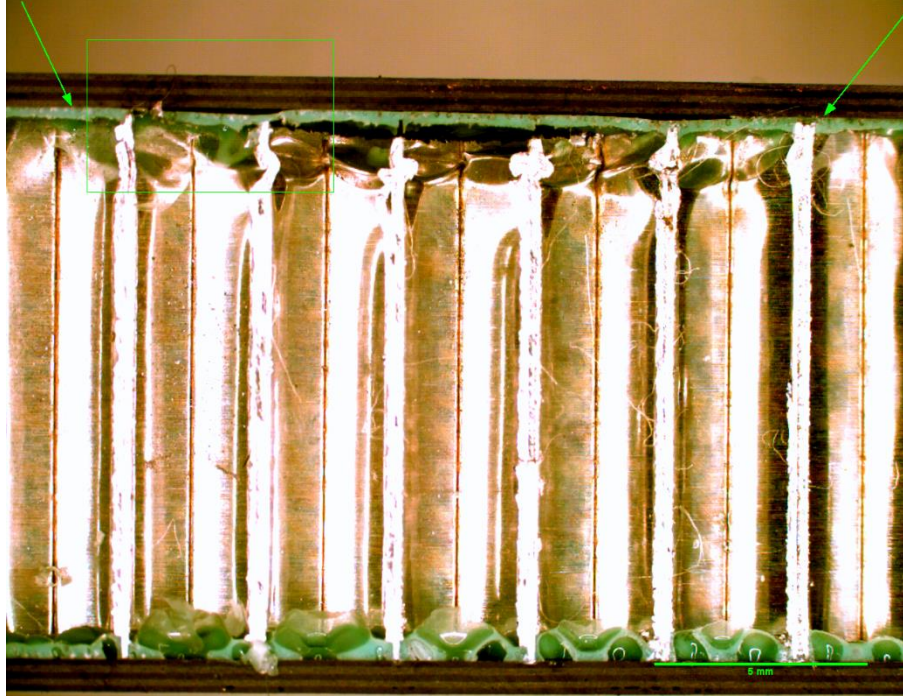
Figure 64: Test Panel 1 (5 Ply, [0/90/0/90/0]) Impact energy of 0.88 J. The green arrows point to where the disbond visually starts and the green box is looked at in more detail in Figure 65. (6.3x zoom) (Scale Bar = 5.0 mm)

The first outlier in Figure 61 represents the 0.88 J Impact and is discussed in further detail below. This was due to the film adhesive not completely disbonding from the face sheet, which did not allow a correct measurement of the depth of core crush. The remaining impact energies displayed a linearly increasing depth of core crush as the impact energy was increased. The maximum temperature recorded for each impact location also displayed this same trend, as shown in Figure 62.

Some of the scatter in the depth of core crush measurements in Figure 61 can be attributed to variations in the bond strength between the film adhesive and the face sheet. The strength of the film adhesive bond can fluctuate in-between different face sheets as well as different regions on the same face sheet. The sanded or non-sanded surface finish and foreign contaminants may differ across each of the face sheets, which can lead to a distribution of energies needed to disbond the face sheet from the film adhesive. The 0.88 J impact location did not completely disbond from the face sheet, which resulted in a smaller disbond depth in-between the face sheet and film adhesive as shown in Figure 64 and Figure 65. The film adhesive around the outer circumference of the impact location has become disbanded from the face sheet, while the film adhesive at the center of the impact location remains bonded. When this happens, the film adhesive is not able to pull the crumpled honeycomb back to its original position before the impact and becomes unbonded from the cell walls. However, if the distance from the bottom side of the face sheet to the top of the honeycomb core is measured, it does not follow the linear relationship established by the other impacts. The measured depth of core crush of 0.57 mm would make this impact energy have a larger amount of core crush than the 1.47 J Impact event which had a measured core crush of 0.56 mm. This may suggest that the face sheet is able to slightly pull the film adhesive and honeycomb core up from its maximum crush depth before the face sheet becomes disbanded from the film adhesive and relaxes back to its original position.

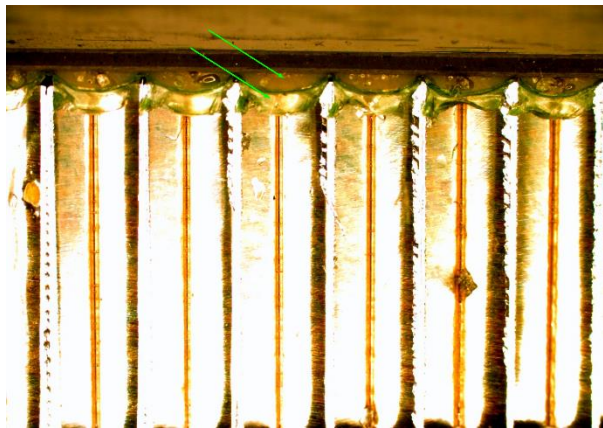
Figure 82: Test Panel 11 (5 Ply, [0/-45/90/+45/0]) The green arrows point to the two layers of film adhesive, which are able to absorb extra thermal energy.

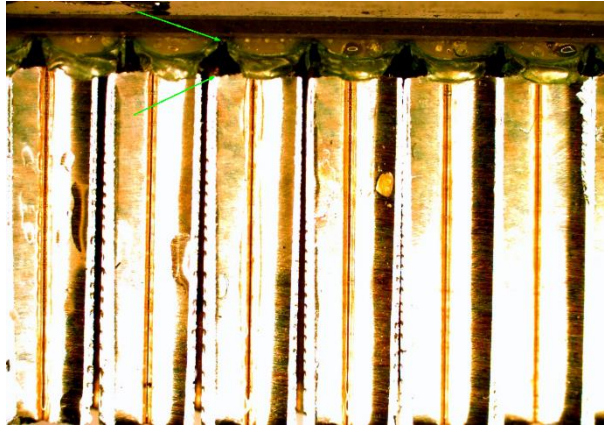
Figure 85: Test Panel 11 (5 Ply, [0/-45/90/+45/0]) Impact energy of 0.88 J. The green arrows point to where the honeycomb core has become unbonded from the film adhesive, leaving a small void.

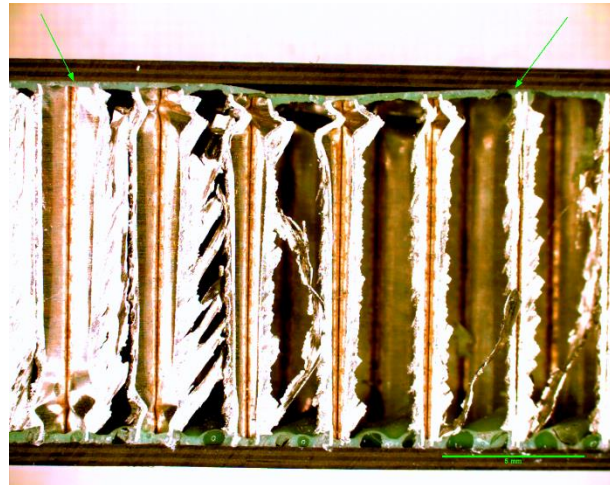
Figure 95: Test Panel 1 (5 Ply, [0/90/0/90/0]) 0.7357 J Impact. Thermography measured width = 25.8 mm (Left), Microscope measured width = 15.3 mm, Microscope measured core crush depth = 0.37 mm (Right).

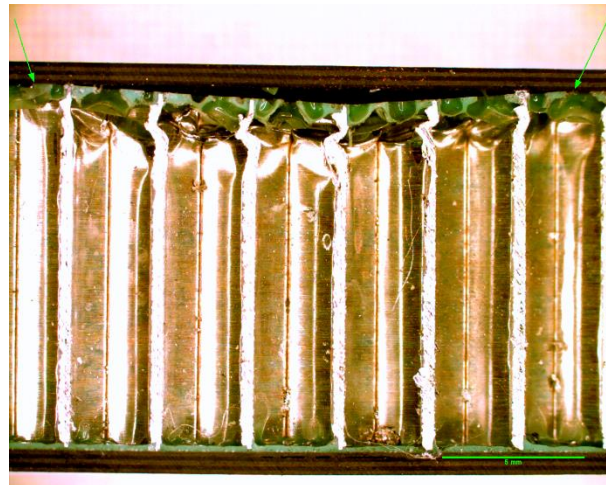
Figure 97: Test Panel 1 (5 Ply, [0/90/0/90/0]) 1.4715 J Impact. Thermography measured width = 27.4 mm (Left), Microscope measured width = 18.8 mm, Microscope measured core crush depth = 0.56 mm (Right).
