# **CHARACTERIZATION OF SANDWICH PANELS SUBJECT TO LOW-VELOCITY IMPACT**

Non-Destructive and Destructive Inspection of  
Non-standard Sandwich Composite Panels

A Thesis Submitted to the Division of Graduate Studies  
of the Royal Military College of Canada  
by

In Partial Fulfillment of the Requirements for the Degree of  
Master of Applied Science in Aeronautical Engineering

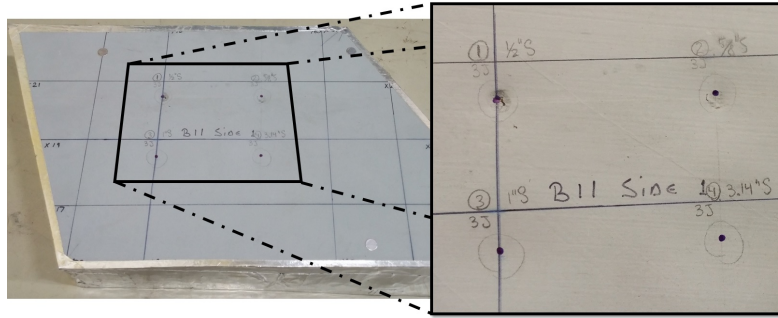
Following impact, a picture was taken of the impacted panel. Panel B11 is detailed in Figure 3.10 showing that the damage was not very noticeable from about three feet away for the larger impactors. The upper-left impactor seen in

Figure 3.10 is the smallest diameter, and has a more noticeable impact from visual inspection, but as later explored, the bottom-right largest impactor leads to a greater damage area.

Figure 3.10: Post impact of panel B11 (smaller diameter impactors seen above and larger diameter seen below).

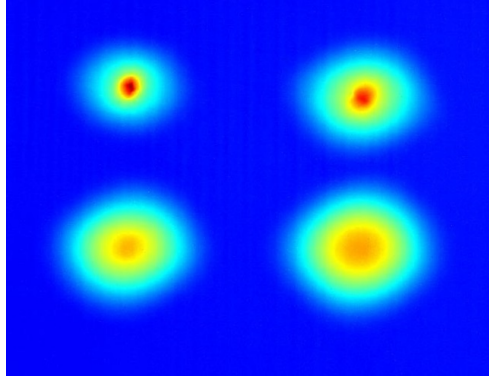
Figure 3.14: Post-processed laser topography of panel B11 (seen in Figure 3.10).

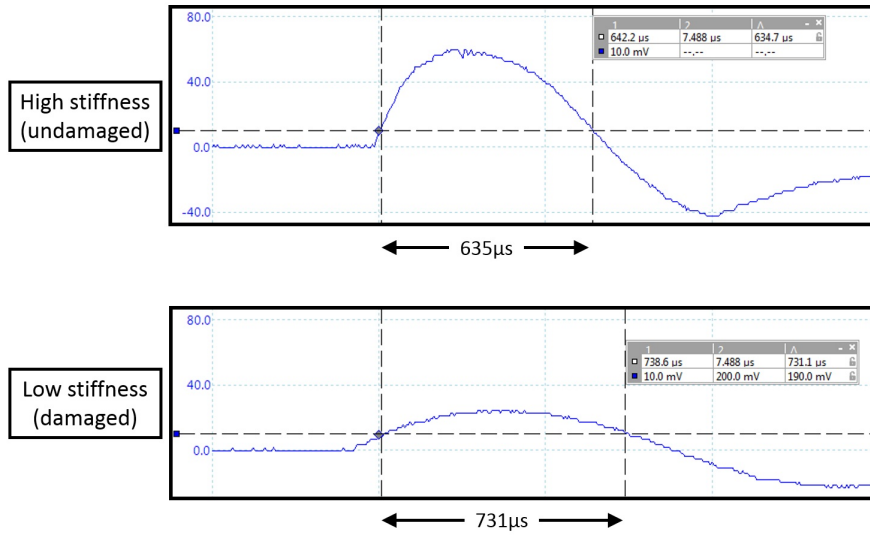
Figure 3.17: Voltage-time history showing high and low stiffness locations. Lower stiffness corresponds to underlying damage.

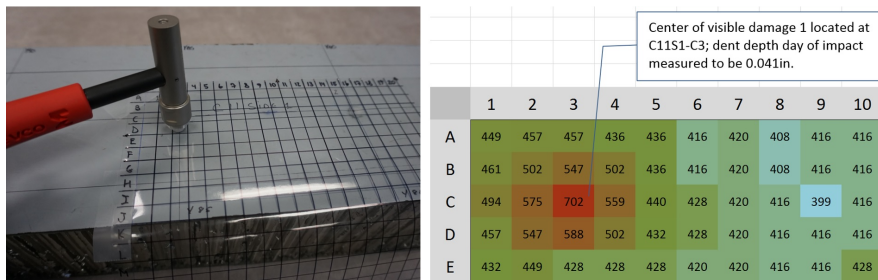
As can be seen in Figure 3.18, an example panel shows how damage can be detectable over an area. By setting a contact time threshold (effectively a threshold for a “damaged” versus “undamaged” stiffness level) the damage area can be approximated, and by looking at the level of contact time, a value can be attached to the amount of damage that is present at a specific location.

Figure 3.18: C-scan tap test with mapped contact time.

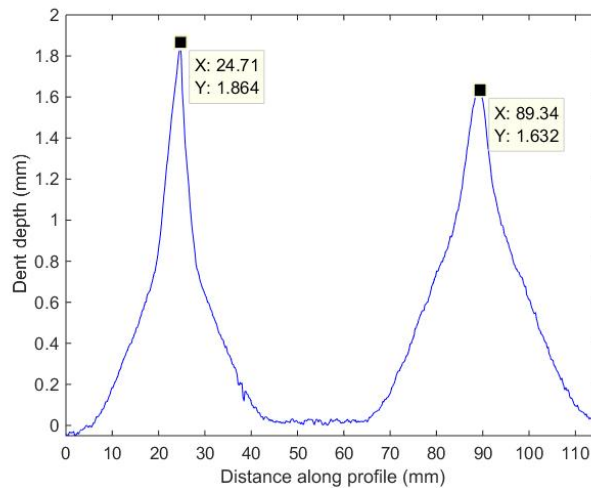
From post-processing of the laser topography measurements, Figure 4.8 shows the B11 dent depth profiles for the 12.7 and 15.9 mm impactors, and Figure 4.9 shows dent depth profiles for the 25.4 and 79.8 mm impactors. The y-axis is stretched compared to the x-axis in order to better show the dent depth. Note that the greatest depth is achieved with the 12.7 mm impactor, while the least depth was the 25.4 mm due to variability in setting the exact drop height (the 79.8 mm impactor would be expected to have the least depth). Normalizing impact depth for actual impact energy does confirm this relationship.

Figure 4.8: Dent profile for B11 across 12.7 (left) and 15.9 mm impacts (right).

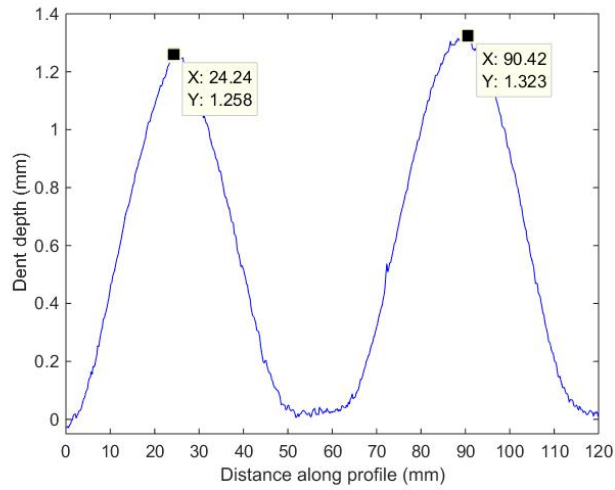
Figure 4.9: Dent profile for B11 across 25.4 (left) and 79.8 mm impacts (right).

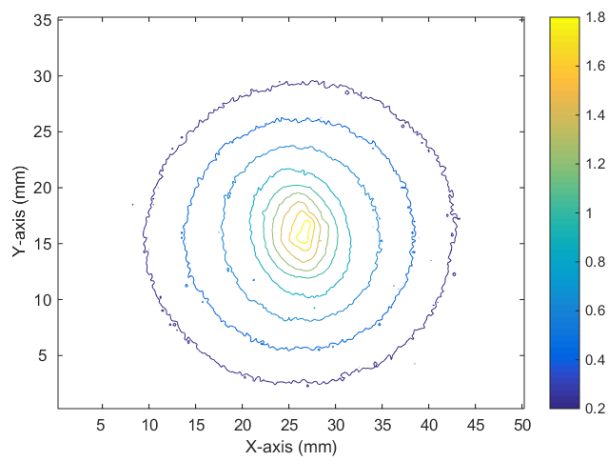
Figure 4.13: Contour of B11 12.7 mm impact.

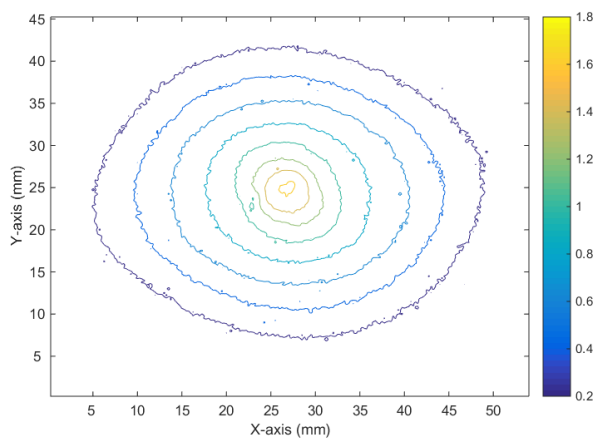
Figure 4.14: Contour of B11 15.9 mm impact.

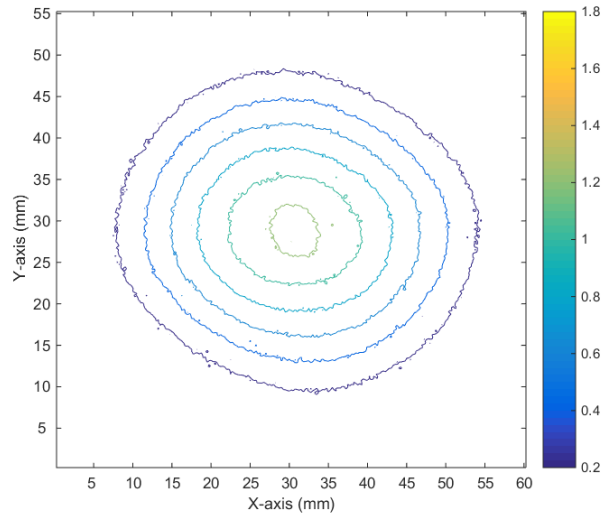
Figure 4.15: Contour of B11 25.4 mm impact.

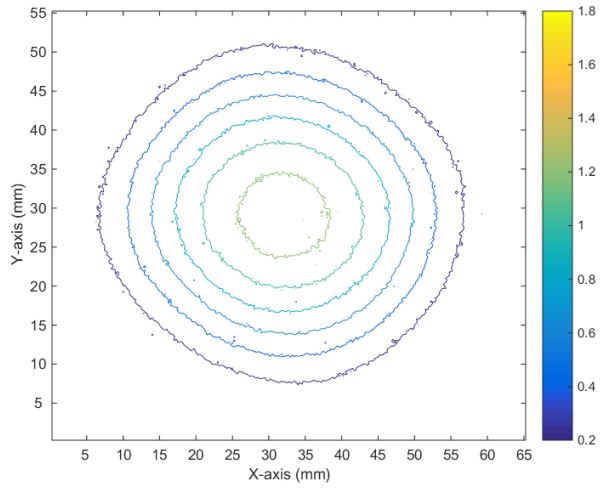
Figure 4.16: Contour of B11 79.8 mm impact.

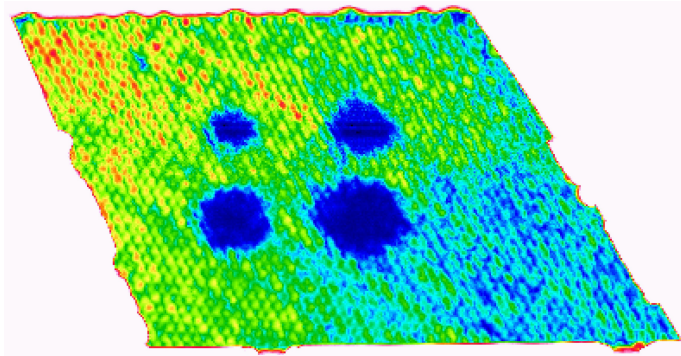
Figure 4.17: B11 after impact through-transmission ultrasound. Damage diameter 30.5, 40.6, 43.2 and 61.0 mm respectively from smallest to largest impact.

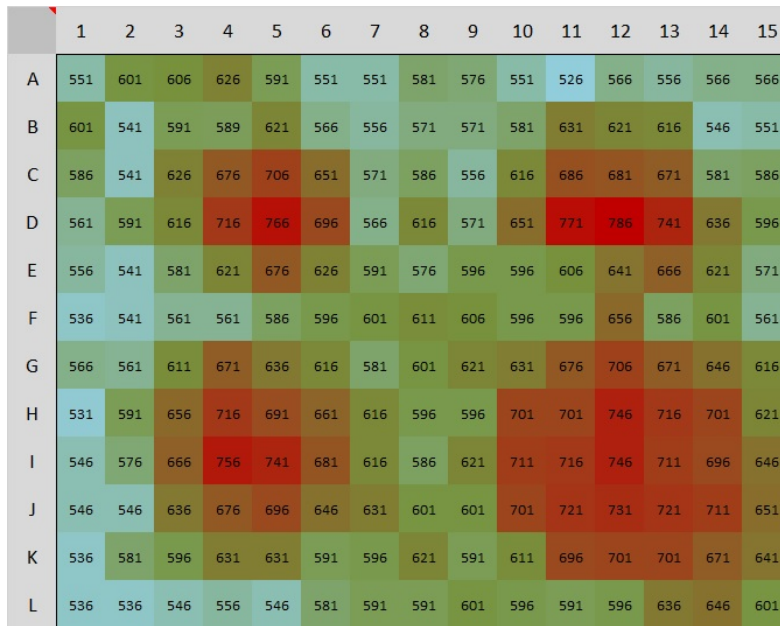
The damage diameter was also determined by carrying out the C-scan tap test as per section 3.3.6; Figure 4.18 shows the local contact time map for the damaged B11 panel. By subtracting the average contact time for the panel, and determining the standard deviation, a  $3\sigma$  contact time was applied as the damage threshold. Damage areas using this threshold are shown in Figure 4.19.

Figure 4.18: Local contact time map for B11 ( $\mu s$ ).

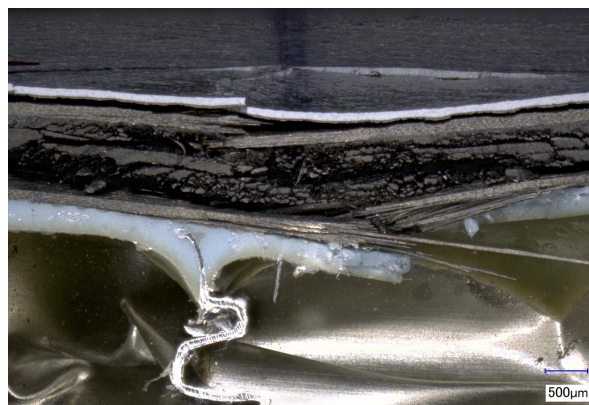
Under greater magnification in Figure 4.23, the failure mode is mixed: fibres under the impact zone are all damaged and the bond between the core and laminate has cracked (along with the crushed core previously mentioned). The profile section of the B14 12.7 mm impact is shown in Figure 4.24 and has very similar damage.

Figure 4.24: B14 12.7 mm local impact zone.

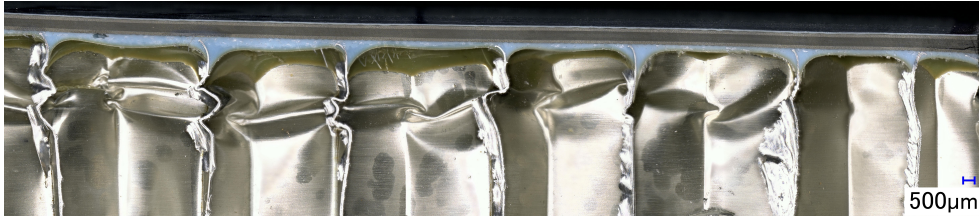
Figure 4.30 shows that for the largest diameter impactor the failure mode has shifted exclusively to core crush. There is no laminate damage, however it can be seen in Figure 4.31 that the paint above the laminate has cracked. The 79.8 mm impact on B14 utilized the same impactor and energy level as B11. The same outcome was observed: core crushing was the only damage caused by the largest diameter impactor, with no delamination as seen in Figure 4.32.

Figure 4.32: Core crushing of B14 79.8 mm impact. Note some delamination along right edge of the laminate; this was likely a result of the rough-cutting, and is not a result of impact.

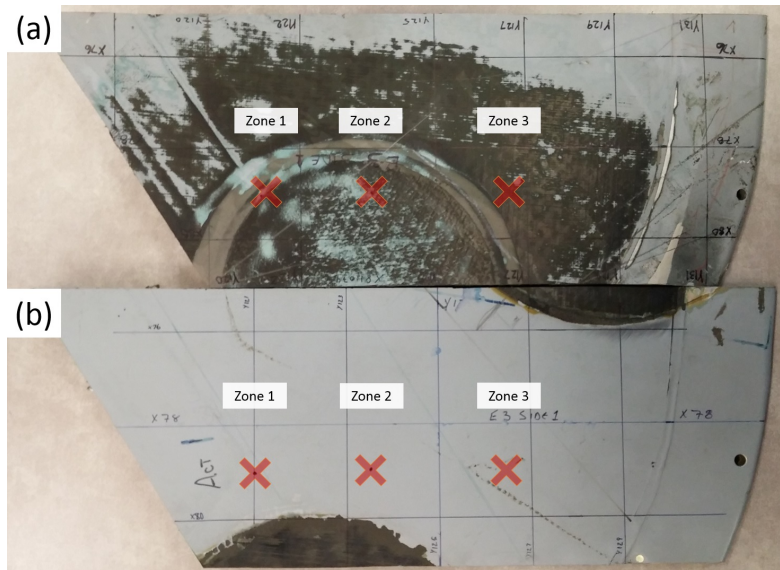
Figure 4.34: Repaired (a) panel E3R with patch and (b) regular panel E3. For the repaired panel, zone 1 is along the edge of the repair where the plies and thickness begin to taper off, zone 2 is in the center of the repair where there is increased effective facing thickness of the patch/panel combination, and zone 3 is just outside the repair patch.

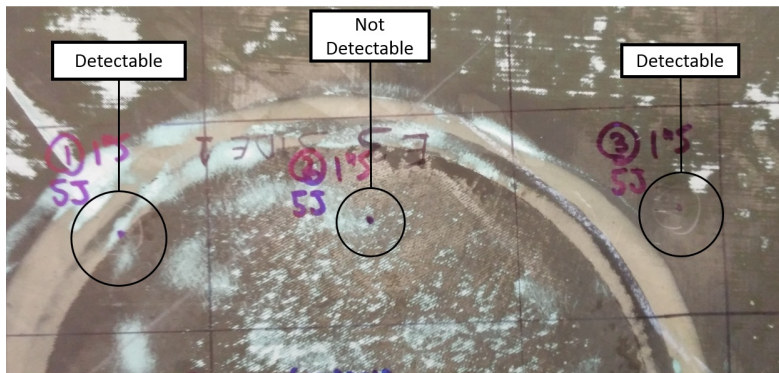
Figure 4.39 shows the regular panel following impact. All impact damage was visible.<sup>2</sup> Figure 4.40 shows the repaired panel; while the zone 1 and zone 3 impacts were detectable, the zone 2 impact in the middle of the repair patch was not noticeable. Table 4.10 shows the dent depth micrometer measurements for both panels. The regular panel dent depths were comparable. The edge of the repair provided some additional dent resistance when compared to the regular panel, the center of the panel showed almost no indentation at all due to additional stiffness of the patch, and outside the repair patch the impact led to even greater dent depth than that of the regular panel.

Figure 4.40: E3R post-impact with zone 1 and 3 impacts visible, but zone 2 was not visually detectable.

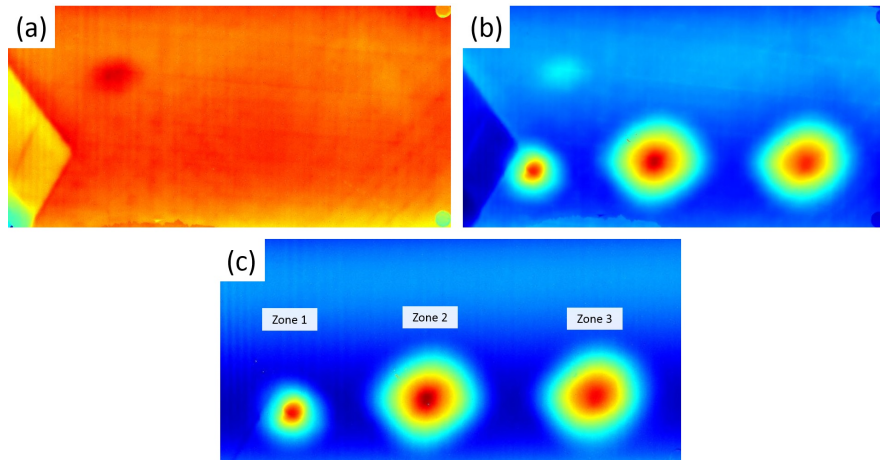
Figure 4.41: E3 (a) before impact, (b) after impact, and (c) deviation map showing smaller zone 1 dent diameter when compared to the other impacts. All impacts 5 J performed with 25.4 mm impactor.

Figure 4.41 shows the topography map for the regular panel before impact, after impact, and the deviation map between these scans. The zone 1 impact as seen in Figure 4.41 (c) has a smaller diameter than the other two impacts, since this zone is higher density core than on the other side of the splice as seen in Figure 4.42 (b).

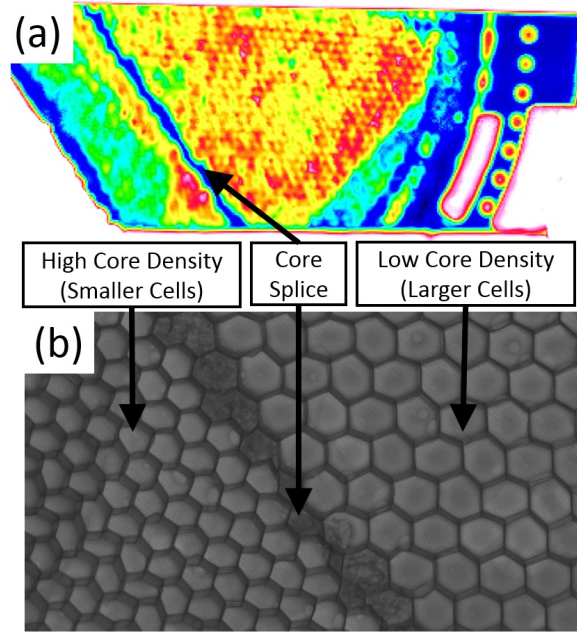
Figure 4.42: (a) Ultrasound and (b) X-ray of E3 core cell geometry showing core splice, higher and lower density core.

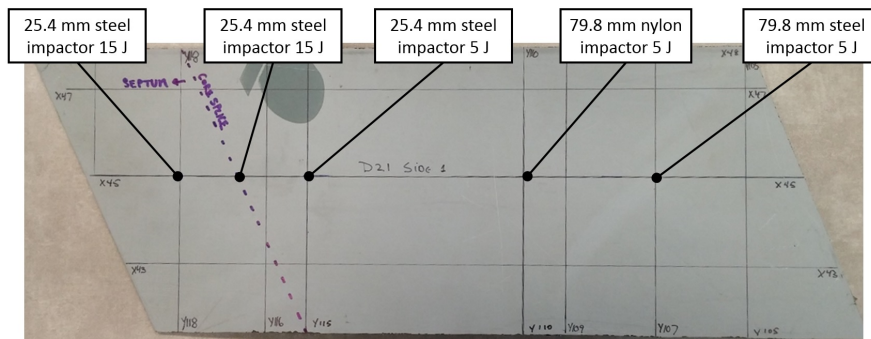
Panel D21 is a trailing edge specimen that was impacted at five locations as shown in Figure 4.49. Some unique internal details of the specimen are seen in Figure 4.50. The first impact was a 15 J impact with a 25.4 mm steel

impactor on the trailing edge (higher energy was used since it was known that this area was stiffer due to a septum that provides additional rigidity). The second impact was also 15 J with a 25.4 mm steel impactor on the core splice which divides the trailing edge from the remainder of the sandwich panel. All other impacts were 5 J impacts with a 25.4 mm steel impactor, 79.8 mm nylon impactor and 79.8 mm steel impactor respectively. The larger impactors were chosen to see if blunt impactors could be identified.

Figure 4.49: D21 impactor type and energy level. Higher impact energy was used at septum and core splice because these locations have higher impact resistance. Different impactor materials were used for the blunt impactors to see if this had any effect on damage or detectability.

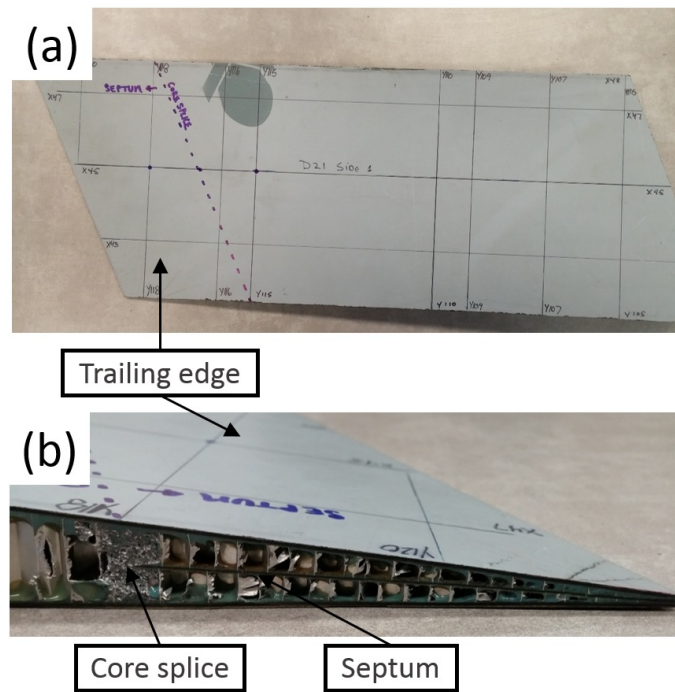
Figure 4.50: Trailing edge of panel D21 noting septum (to provide additional rigidity) and core splice.

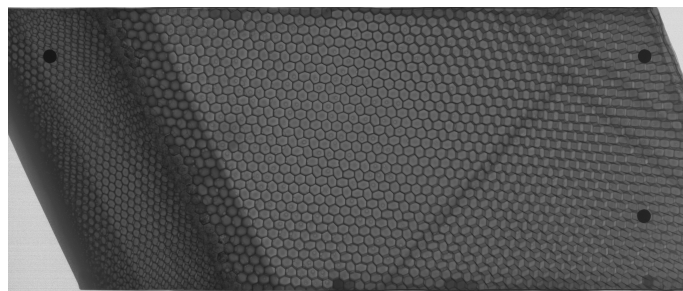
Figure 4.51 shows the radiographic image of the damaged panel. This appears to be the most difficult method to detect damage of the three studied. Cracks in the laminate can be detected by this method, and core crushing will show up as a shift in the pattern of the honeycomb cells from the surrounding cells. Careful analysis is required to detect damages with radiography.

Figure 4.51: D21 after impact radiographic image. Shifting in cells reveals core crush, however it is challenging to identify impact with this method.

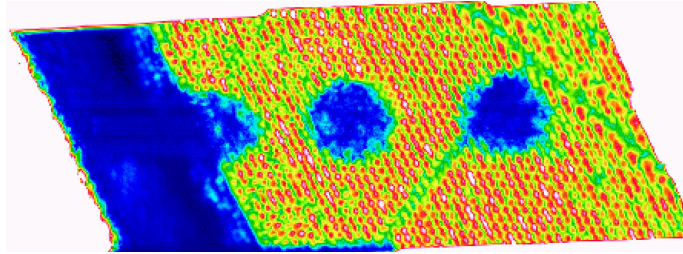
Figure 4.52 shows the through-transmission ultrasound of D21. This shows three of the impacts quite clearly, but due to the additional thickness of the core splice and higher density trailing edge, two of the impacts are obscured and were not detected by this method.

Figure 4.52: D21 after impact through-transmission ultrasound. Higher density septum on the left of the panel obscures damage for two of the five impacts.

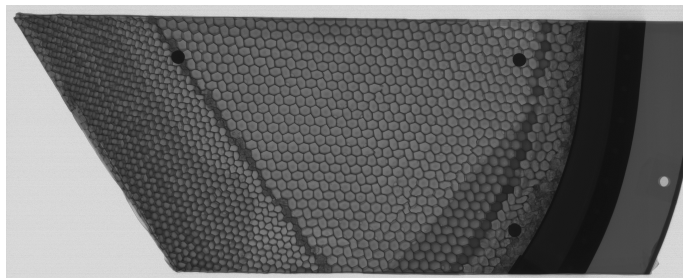
Figure 4.54: E3 after impact radiographic image

A radiographic image of panel E3 is shown in Figure 4.54 with some close inspection reveals core crushing due to warpage at the impact locations, but as with the previous panel this method does not detect damages from impact as well as ultrasound or C-scan tap test.

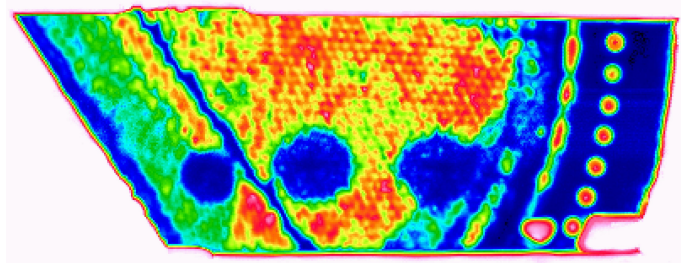
Figure 4.55: E3 after impact through-transmission ultrasound

Figure 4.55 shows the through-transmission ultrasound of E3. This clearly shows the areas of damage, and reveals that the first impact has a smaller diameter than the other two. The reason for the leftmost (zone 1) impact having a smaller damage diameter is due to the higher density core at this location.

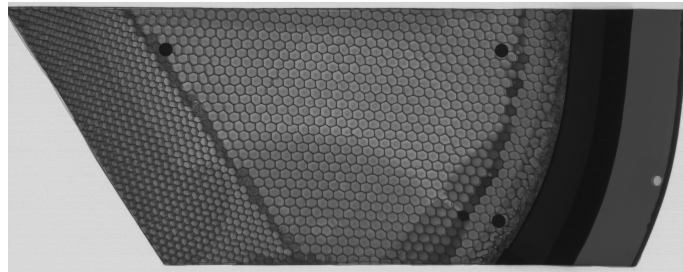
Figure 4.57: E3R after impact radiographic image

Figure 4.57 shows the radiographic image of panel E3R. It is very difficult to identify the damaged areas for this panel using this technique. Figure 4.58 shows the through-transmission ultrasound of E3R. All impacts and their respective sizes are easily detected, and the repair patch and splice are seen using this method.

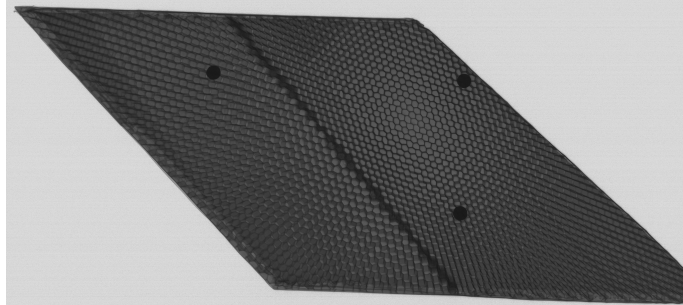
Figure 4.60: F3 after impact radiographic image

Figure 4.60 shows the radiographic image of the panel, with the different core sections and core splice running down the middle. It is difficult to detect core crushing in this image. Figure 4.61 shows the ultrasonic scan of F3, and although there were four impacts, their proximity has made damages blend into one large damage area. The higher density core on the right-hand side leads to less dispersion of damage. Figure 4.62 shows the C-scan tap test of the panel; the result is very similar to the ultrasound, with the damages blending into one central area of stiffness loss for the panel. Lower contact time areas correctly identify the core splice location.

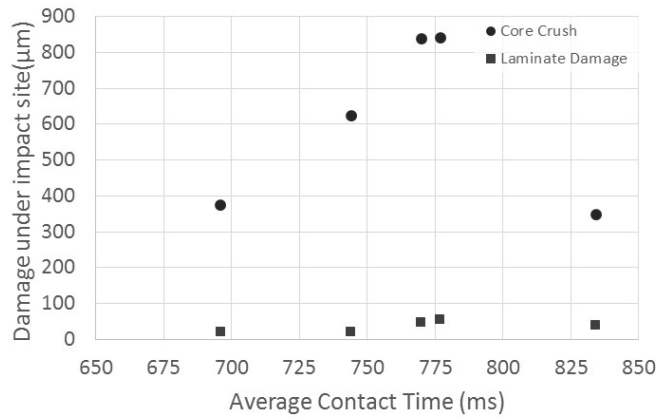
It was found through contact time measurements of the damage incurred under the impact zone that there is a relationship between this damage and the decrease in stiffness. Contact time increases with local stiffness decreasing which relates to the amount of damage incurred. Impacts at 3 J for panels with equivalent facing thickness and core density were studied to see if the C-scan tap test could provide some indication of failure mode, or the extent of the failure caused by the impact. Figure 4.63 shows a trend of increased contact time with more significant underlying core crush (with the exception of one data point). It is difficult to ascertain if there is a noticeable pattern with laminate damage.

Figure 4.63: Damage at the impact zone (measured when sectioned) against contact time. Core crush increases with contact time.

As seen in Figure 4.63 as panel stiffness decreases due to impact damage, contact time increases with measured cross-section core crushing. No definitive relationship is detectable between observed laminate damage and contact time; crushed core has a greater influence on local stiffness reduction than laminate damage.

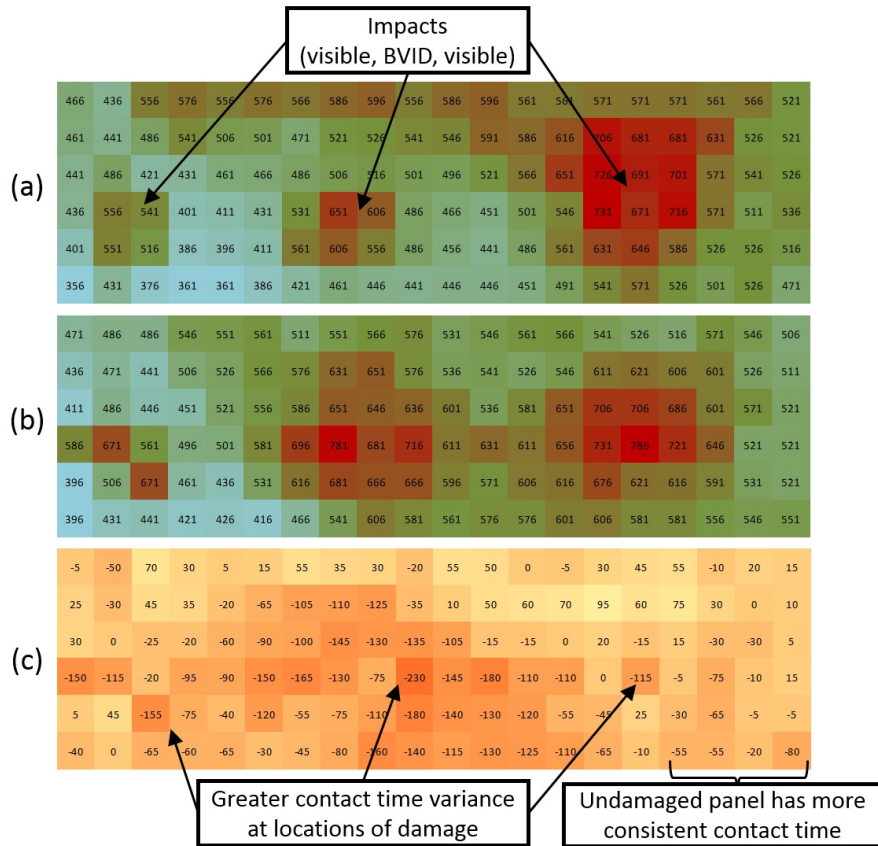
Figure 4.64 shows the C-scan tap test for the panel E3R, repeated to show the degree of variation that can occur between repeated tests. In both cases (a) and (b), the impact areas are all identifiable, showing a local loss of stiffness as greater contact time than the surrounding area. Figure 4.64 (c) shows the difference between two repeated tap tests of panel E3R. Note that for undamaged areas, the variance is not as significant as for the damaged areas. The tap test confirms some details about the first impact on the panel (leftmost impact). The change in local stiffness is less for this 5 J impact, since the surrounding area is a stiffer (light blue area). This indicates that the core is stiffer, and higher density than the remainder of the panel. Looking at an area with less stiff surroundings, such as the third (rightmost) impact, the damage is spread out over a greater area as a result of the lower density core.

Figure 4.64: E3R C-scan tap test showing (a) first scan, (b) second scan and (c) the difference between the two scans. The difference between the C-scan tap tests shows greater variability when impacting a location of damage.

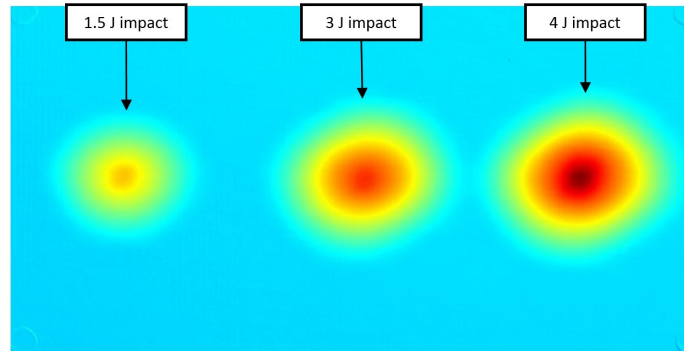
Figure 4.65 shows the deviation map after impact, showing only the dent profiles. As expected, the dents increase in depth and diameter as the energy level increased. To detect small changes in the dent profiles, topography maps were subtracted from the baseline map seen in Figure 4.65. This provided an image that shows only the change in the dent profile over time, or 'relaxation' of the dent. Figure 4.66 shows the relaxation of panel B12 over a period of seven days. After day one, the change in dent profile is minimal and within the noise of the laser, however the trend is towards a greater change in dent depth and overall profile over time.

Figure 4.65: Laser topography baseline deviation map of panel B12 for relaxation study, showing 1.5, 3 and 4 J impacts. Dark red indicates greater depth, whereas blue indicates a flat surface.

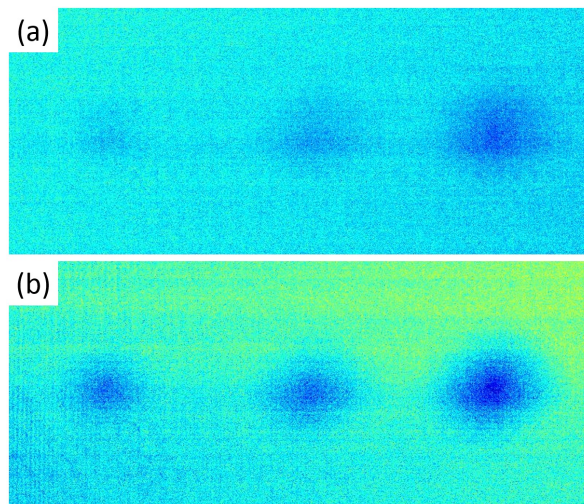
Figure 4.66: Dent relaxation for B12 over one week: (a) after one day; and (b) after seven days. Fuzzy images are a result of the small measurements within the limits of the laser's accuracy. Darker blue indicates greater change in depth.

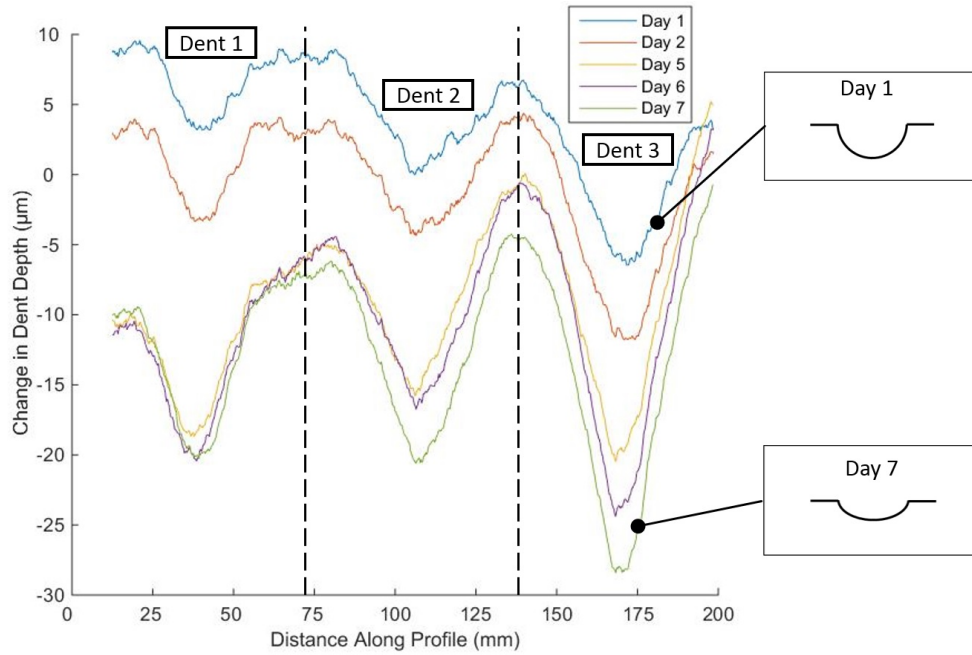
Figure 4.67 shows the dent depth profiles over the seven day period. The troughs of the profiles (i.e. dent depth) changes more than towards the edge of the dents. Figure 4.68 shows the maximum depth for the three impact locations over a period of seven days.

Figure 4.67: Long term dent relaxation profile B12 over time showing the dent depth and profile reducing over time. Plot created using average of scan

Figure 4.67 shows that there is both a local and global relaxation occurring in the panels over the period observed. When observing the edges of the dent profiles, these change over time along with the center of the dent. One edge relaxes more than the other. This could be a source of error (e.g. very small temperature changes leading to global measurement changes) or could be a phenomenon. Locally, the center of the dent profile for all indentations has a greater change over time, which is the expected relaxation. The reason for the center of the dent changing more than the edges of the dent is shown in Figure 4.69, similar to a slack rope being pulled taut.
